Main Reasons of Structural Wall Collapse in Chile 2010 and New Zealand 2011 - Implications For Ecuador

Maria Cristina Avalos Aguilar*, Ana Gabriela Haro and Pablo Caiza Sánchez

Abstract: Previous works on the earthquakes of Chile 2010 and New Zealand 2011 indicate regular behavior of reinforced concrete buildings with structural walls. However, some buildings suffered significant damage associated with global or local collapse due to diagonal cracking and flexural-compression failure. Structural walls located at the ground floor presented tension-compression failure was probably provoked by high axial forces at the walls extreme ends which could cause this failure in places where there is a lack of bracing and confinement.

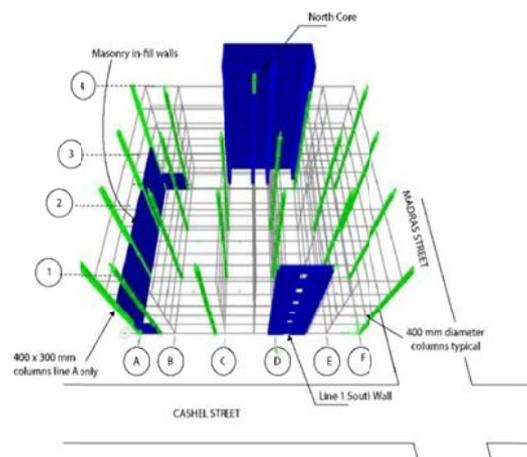
Fig. (1). CTV Building, Structural walls location [5].

The collapse produced in 6-storey CTV (Canterbury Television) building produced about 63.5% of all the reported deaths. The structure presented regularity in plan with 4 axes in Y direction and 6 axes in X direction, with two walls: the North Core around the stairs and the lift and the South Wall in the Southern part of the building. In the western part there was a masonry wall between the columns and the beams from the first three floors, as shown in Fig. (1). The center of rigidity was away from the center of mass. The slabs separated from the North Core and large displacements caused critical columns to fail.

In the case of the CTV Building after the Darfield Earthquake the columns presented cracks due to the non-ductile reinforcement distribution. It was less than the minimum required reinforcement for shear in circular columns. Additionally, large portions of concrete cover, low concrete compression strengths critical columns, and lack of ductility in the beam-columns joints, which provoke fragile columns, were reported. The forces and displacements produced during the 6.3 Mw earthquake affected the critical columns and made them overloaded. Consequently, it provoked failure on the contiguous slabs [5].

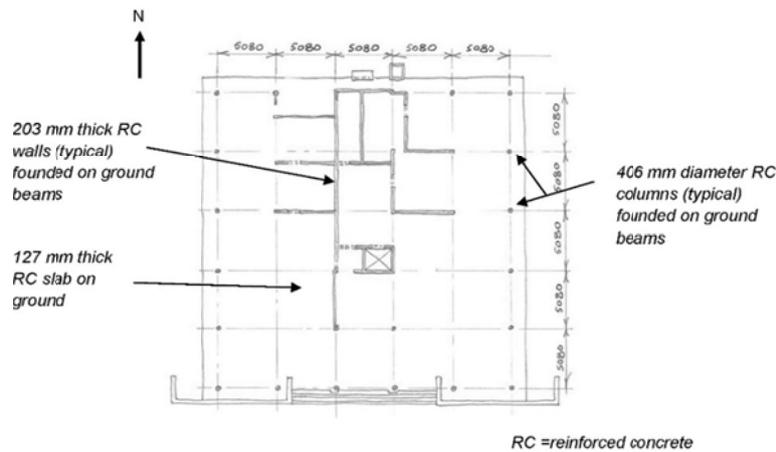
Fig. (2). Ground Level Plan of Pyne Gould Corporation [6].

The five-storeys Pyne Gould Corporation building constructed in 1960 suffered total collapse resulting in 18 deaths and 28 people injured rescued from the debris. It had regular horizontal area, with the same number of resistant lines in X direction and Y direction. The RC structural wall was 203 mm thick. The central walls and the cantilever of the first floor present eccentricity as shown in Fig. (2). The joints between the columns and the beams, and the connections between the structural wall and the slabs, failed causing the floors to fall down.

As well as the CTV Building, the PGC Building did not present a ductile response, because of the year of construction (1960), and the walls were designed to support loads and accelerations established from the 1960s. If a comparison is established between the Code NZS 1960 and the NZS 3010:2006, NZS 1170, the older one only would fulfill 30 to 40% of the new one [11].

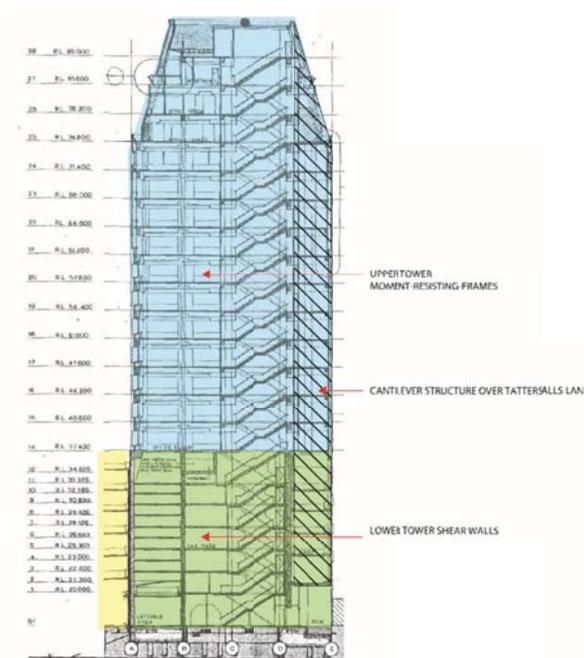
Fig. (3). Vertical Irregularity of Grand Chancellor Hotel [7].

The 22-storeys Grand Chancellor Hotel building did not report deaths during this earthquake; it was built between 1985 and 1988 with horizontal and vertical irregularities as shown, (Fig. 3). The upper tower relied on a reinforced concrete frame for seismic resistance, and the lower tower relied on a reinforced concrete structural wall. The earthquake caused the rupture of the structural wall in the south east corner of the Hotel, which produced a 0.8 meters deformation, approximately, and a horizontal deflection of 1.3 meters at the top of the Hotel. The loading aspect ratio of the wall was high, and during the ground motion it attracted additional loading. Flexural actions concentrated these axial loads at one end of the wall, and unconfined concrete is very likely to suffer brittle compression failure [7]. This building was demolished after the earthquake.

For example, in the Hotel Grand Chancellor the ground shaking in the vertical direction generated amplified dynamic response from either the upper floor cantilever or the cantilever transfer beams. The current construction code did not consider vertical accelerations at cantilevers, then those elements were prone to fail [10].

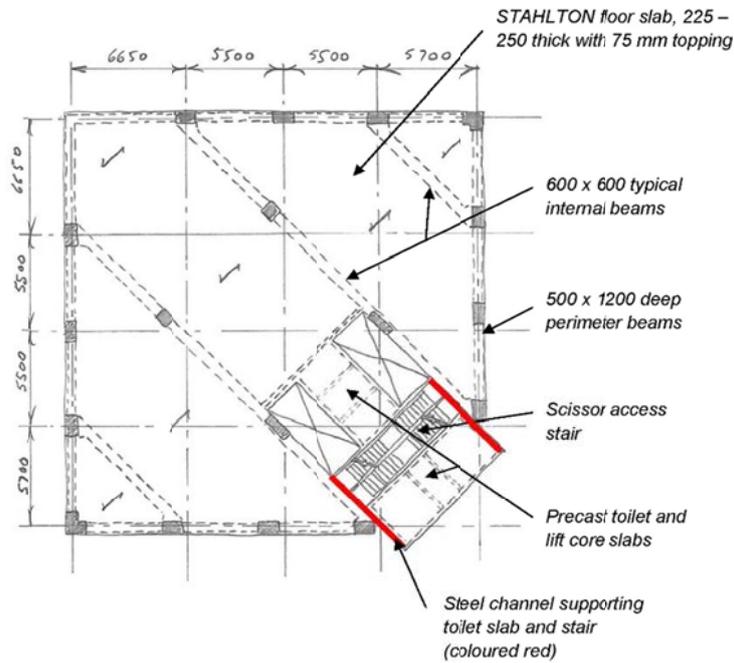
Fig. (4). Floor Plan and location of the scissor stairs of Forsyth Barr Building [8].

The Forsyth Barr Building was a 18 storeys high, which reported minor damage compared to the three structures mentioned above. Before the Christchurch earthquake, Forsyth Barr building presented some structural problems which were the origin of the damage during the tremor. Built in 1988, founded on a shallow raft, the floors extend beyond the footprint of the tower to form a podium on the south and east sides. Failure of a podium column was reported after the

earthquake. The main damage associated with this building is the staircase collapse since occupants were trapped until they could be rescued. The staircases collapsed due to high drift demands. Floor plan and location is shown in Fig. (4).

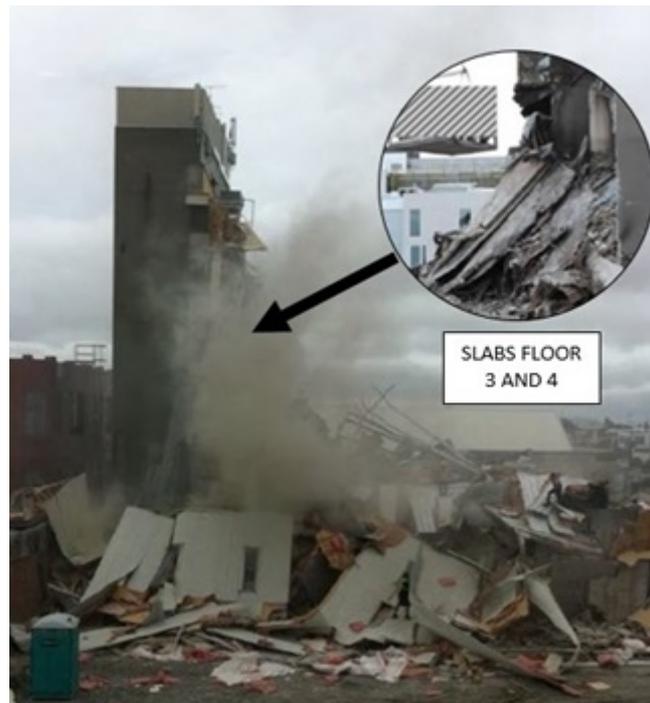
Fig. (7). North Core after collapse [5].

Another fact to be considered is the usage of the building during its service life. The CTV building had experienced different functions like being a hospital, an education center, a library and office building, so the live load had changed causing extra loads that were not included in the original design. Table 1 shows the live loads according to NZS4203:1984. In the distributed load there was no difference between school classrooms and hospital bedrooms, but in the concentrated load there is a high difference. Considering the hospital had a boiler room, the live load changed abruptly compared with an education center and offices. The collapse of the CTV building was attributed to the failure of one of the structural walls. The slabs fell down as a consequence of damaged columns. Only the north core remained as shown in Fig. (7).

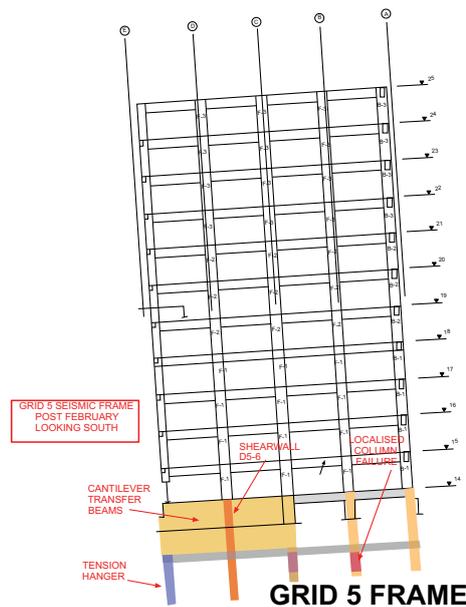
Fig. (8). Collapse of Hotel Grand Chancellor [7].

In the Hotel Grand Chancellor one of its walls failed due to compression because of the high axial load ratios combined with low levels of reinforcement. This structural wall supported the weight of 8 floors and the lateral seismic loads. As result, the building dropped by approximately 800 mm and a horizontally deflection of 1,300 mm was registered at the top of it. Fig. (8) shows how Hotel Grand Chancellor failed. The building showed lack of robustness

and resilience of the wall, and was not able to support loads in excess. The longitudinal reinforcement and confinement were not appropriate to support axial loads, then the base of one of the structural walls failed.

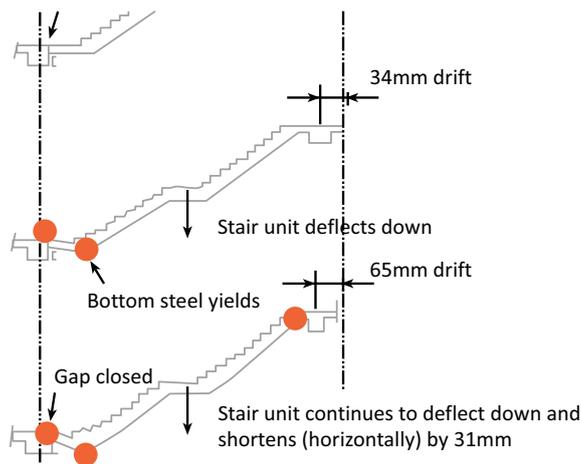
Fig. (9). Stairs of Forsyth Barr [8].

In the case of The Forsyth Barr the stairs shown in Fig. (9) were the only one damaged due to compression, bending downward and yield in its reinforcement. The construction tolerances decreased the required horizontal displacement. The seismic movement gap, considered also as expansion joint, at the base was too small to avoid compressive actions. Some materials were found in this gap, which could have exacerbated the compression forces. The stairs failed from the ground level all through the 14 and 15 levels. Investigations concluded the stairs must be designed to maintain their structural integrity. While scissor stairs are used, a proper design should be done and seismic gaps must be clear, and not reduced. Scissor Stairs are two stairs provided within a single shaft and separated by a light weight partition running between and in all the height of the stairs. Fig (10) shows the stairs after collapse. The maximum inter storey drift for this building predicted at the moment of the earthquake exceeded the required at the time of design by about 80%; it also exceeded the actual Code by about 60% [8].

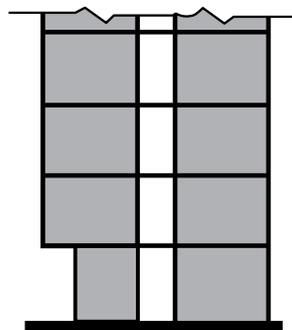
Fig. (12). Alto Rio Condominium irregularity [14].

In addition, modern buildings failed. The 15-storey Alto Rio Condominium located in the city of Concepcion was built on soft alluvium soil and included reinforced concrete walls with an offset at the first level, as illustrated in Fig. (12). It presented slender walls, and lack of confinement at the boundary elements. This irregularity would have increased compressive stresses in the first level so the wall could trigger, making the structure to collapse [14].

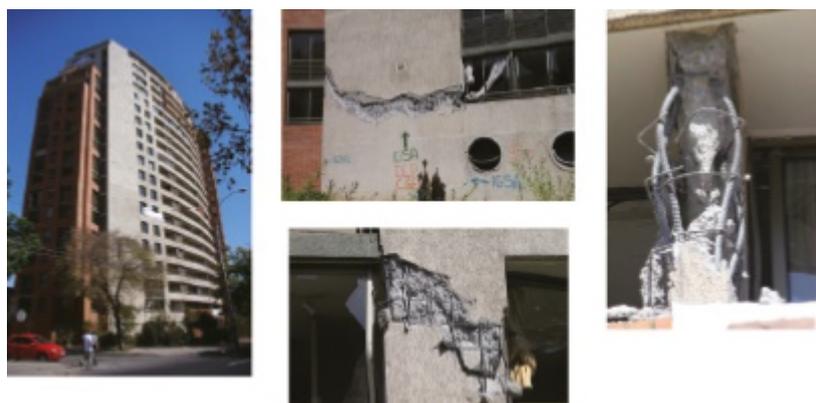
Fig. (13). Tension Compression Failure in Central Park Building [16].

Central Park building in Chile, is a 19-storey reinforced structural wall building that suffered tension – compression failure in one of its walls and columns, also this provoked buckling of the transversal wall where the main bars presented lack of seismic hooks, deficient reinforcement due to small bar diameters, and large spaces between the transversal reinforcement as shown in Fig. (13) [16].
