# The Open Civil Engineering Journal

## RESEARCH ARTICLE

# Experimental Study on Structural Degradation of CFRP Strengthened RC Beams Subjected to Weak Interfaces

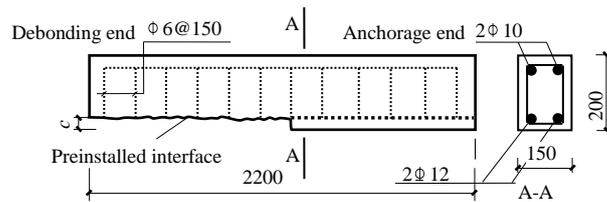
Fig. (1). Configuration of test specimens (dimensions in mm).

(1) Group A consisted of nine specimens; weak interfaces were created by defective bonding between new and old concrete. As shown in Figs. (1 and 2), half of the concrete cover was reserved for secondary construction. After 28 days of curing, the old surface of the reserved part was processed, and the cover was complemented with fine aggregate concrete. Finally, CFRP sheets were applied to the soffit after another curing period.

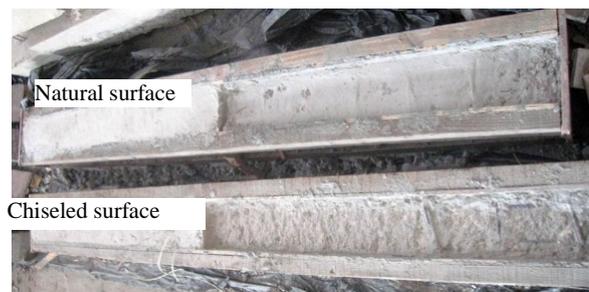
Fig. (2). Beam specimens in Group A before cover recasting.

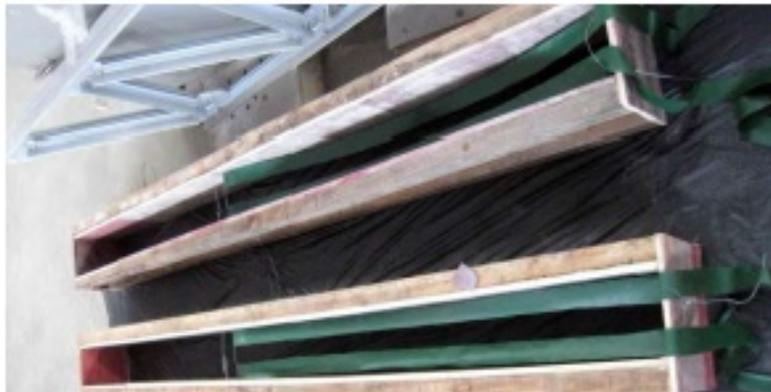
Fig. (3). Embedded oilcloth strips in molds of Group B.

(2) Group B consisted of three specimens; weak interfaces were created by preinstalled cracks generated by symmetrically pre-burying two oilcloth strips, as shown in Figs. (3 and 4). The numbering rule of specimens in this group is as follows: B50 and B80 stand for 50 mm and 80 mm total width of the preset cracks, respectively.

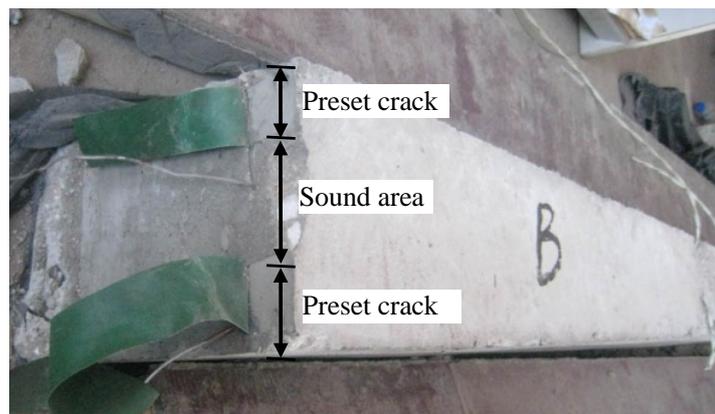
Fig. (4). A typical specimen in Group B (B50-25-140).

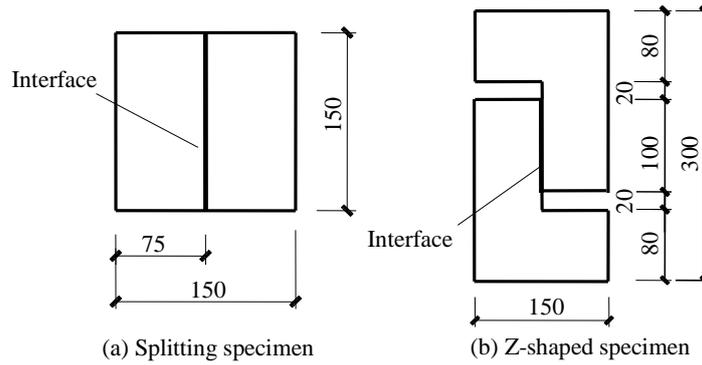
Fig. (5). Sketch of splitting and shear test specimens.

Three cube specimens and three Z-shaped specimens were prepared for each strength level to determine the splitting tensile strength and shear strength, respectively. Sketches of the specimens are illustrated in Fig. (5), and the unspecified thickness is 150 mm. Halves of those specimens were constructed with the same concrete as the mean body of the beam specimens. After the first curing period, the bonding surfaces were treated with one of the three procedures explained above, and the other halves were constructed with the complementary concrete. After another curing period of 28 days, the specimens were tested, as shown in Fig. (6) [12].

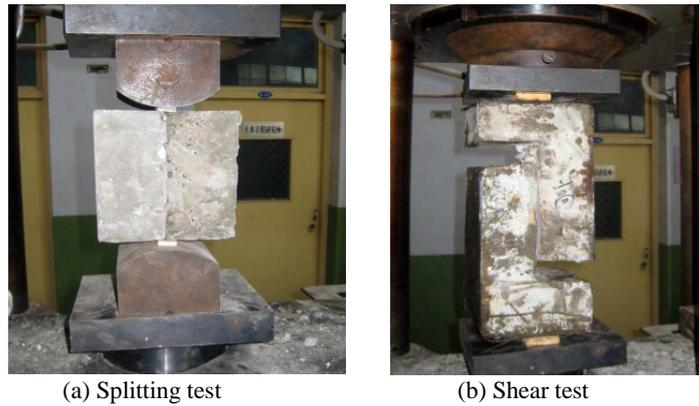
Fig. (6). Splitting and shear strength tests.

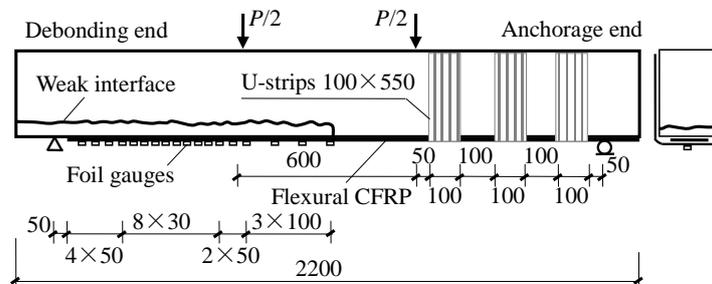
Fig. (7). CFRP strengthening scheme (dimensions in mm).

As shown in Fig. (7), flexural CFRP was bonded to the soffit of the beam specimen extending 50 mm away from the supports. For all specimens, three U-strips with a width of 100 mm were set unexceptionally at the anchorage end to ensure that debonding failure would take place at the debonding end. The same U-strips were applied symmetrically at the debonding end only for three specimens, including L-25-140-U, M-25-140-U and B80-25-140-U, to investigate the effectiveness of U-strip confinement.

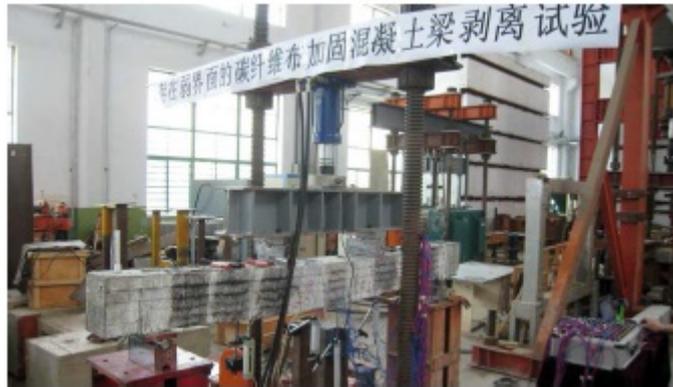
Fig. (8). Site of flexural test setup.

The beams were simply supported and tested under four-point bending, as seen in Fig. (8), which depicts the test

site. Mid-span deflection was measured by linear variable displacement transducer (LVDT), and foil gauges were densely glued onto the flexural CFRP sheet, as seen in Fig. (7). A vertical load was applied at steps of 3 kN until yielding of the embedded tensile reinforcement, succeeded by continuous loading until ultimate failure occurred. All of the data were collected synchronously by computer.

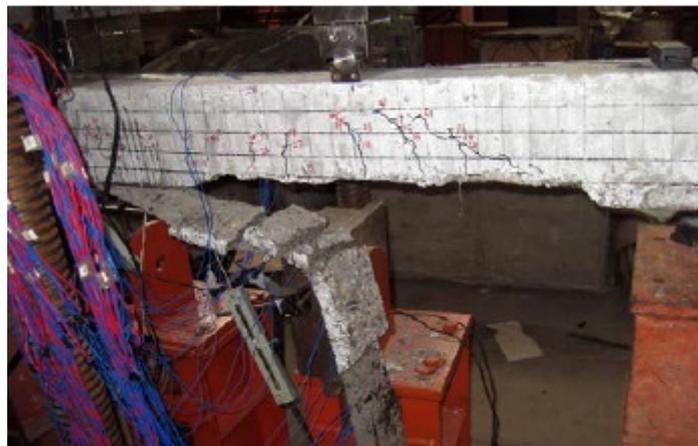
Fig. (9). Large-scale peeling off of concrete cover (M-25-140).

A typical integral CFRP debonding failure (denoted as DB in Table 2) occurred in the reference specimen along the epoxy-concrete interface. Similar integral debonding took place for specimens in Group A without lateral confinement at the debonding end. Intermediate cover delamination along the weak interface was observed prior to yield of tensile reinforcement, and blocks of separated concrete cover peeled off with the flexural sheet under ultimate failure, as shown in Fig. (9). This intermediate cover separation observed in individual specimens is roughly classified into three grades according to its scale, and results for cover separation are also listed in Table 2.

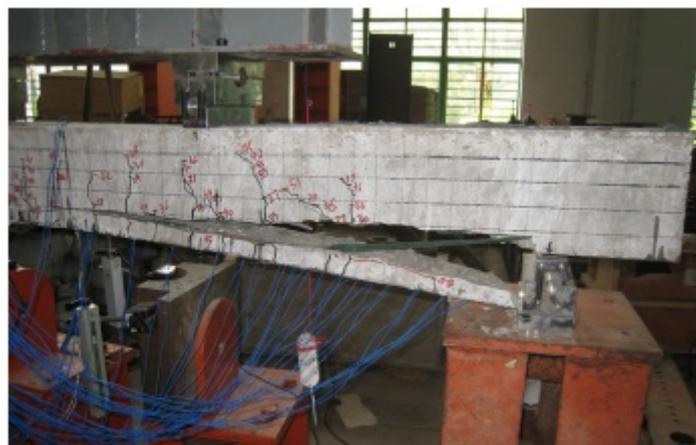
Fig. (10). Typical failure mode of specimens with preinstalled cracks (B80-25-140).

For specimens in Group B, which had weak interfaces induced by preinstalled cracks, the failure took place in a more brittle way than the specimens of the Group A. The whole cover abruptly separated from the main beam (denoted as CD) at the ultimate state, and only ambiguous relative slippage could be observed along the weak interface previously, as shown in Fig. (10).

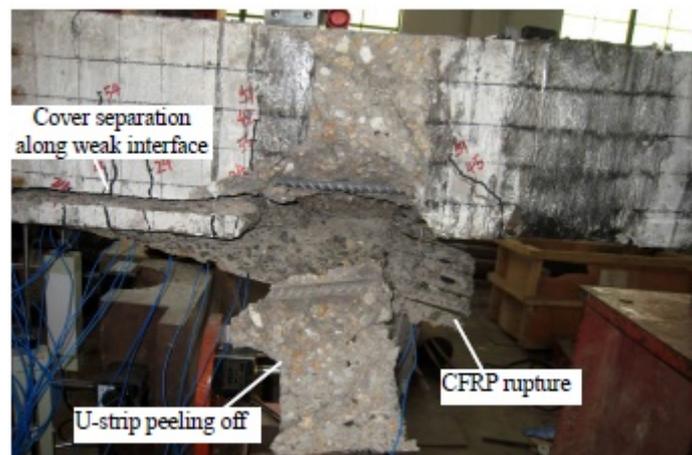
Fig. (11). Typical failure mode under U-strip confinement (M-25-140-U).

Under U-strip confinement at the debonding end, integral debonding of flexural CFRP could be effectively inhibited. Specimen L-25-140-U, M-25-140-U and B80-25-140-U all failed by rupture of the flexural CFRP sheets (denoted as FR), sometimes preceded by U-strip detachment (denoted as UD), as shown in Fig. (11). In addition, signs of cover separation were observed prior to ultimate failure. In this case, the ultimate strains of CFRP rupture failure listed in Table 2 are far below to the material property which may be explained by the following reasons. Firstly, the ultimate elongation of CFRP material property is determined from ideal tensile test, while in real situation premature rupture of flexural CFRP are quite normal due to uneven tension of strips, locally defective binding, crack of substrate concrete, etc. Additionally, complex stress condition caused by U-strip confinement is another factor which may induce flexural CFRP rupture at low strain. It can be clearly illustrated in Fig. (11) that the rupture occurred right along edge of a U-strip. Since it is impossible to predict the rupture point, herein mid-span strains were listed to make a rough comparison.

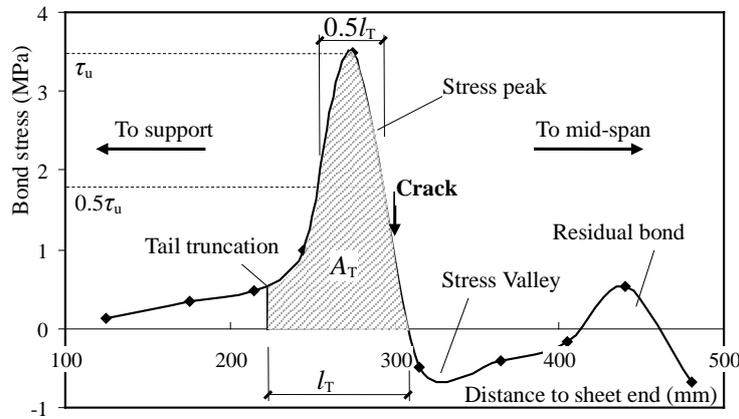
Fig. (12). A typical segment of a bond stress distribution curve.

Once the bond stresses at discrete points have been determined using Eq. (1), the distribution curve of the bond stress can be plotted along the CFRP sheet using spline interpolation. Fig. (12) shows part of a typical distribution curve in which the definitions of characteristic parameters of CFRP debonding are illustrated. Bond stress between the CFRP sheet and the concrete is created by two effects: the internal moment variation in the longitudinal direction and retraction of the cracking concrete. Herein, these effects are, respectively referred to as shear bond stress and cracking bond stress. Theoretically, shear bond stress has the same direction in either half span of a bending beam, while crack bond stress distributes symmetrically over a crack in opposite directions. Superposition of the two stresses engenders the actual bond stress distribution. As shown in Fig. (12), a stress peak is formed on one side of a crack near to the support, while a stress valley is formed on the other side. If no new cracks occur, the curve will maintain approximately the same shape as its value increases, until the peak reaches the ultimate bond strength. At this critical state, local debonding takes place, and a new stress peak may be formed near the support after bond stress redistribution, or, in some cases, the local debonding might expand unstably and rapidly develop into an integral debonding.

The ability to resist debonding can be represented largely by the bond stress peak at the critical state, and this peak has great significance in establishing a model of anchorage strengthening at the critical state. Herein, three characteristic parameters are proposed to describe the bond stress peak, including ultimate bond stress  $\tau_u$ , bond transfer length  $l_T$  and enveloping area  $A_T$ . As shown in Fig. (12),  $l_T$  is the breadth of the peak, or the double breadth of one half peak in the case of a long tail.  $A_T$  is the enveloping area of the peak in the range of  $l_T$ , as illustrated by the shaded area in Fig. (12).

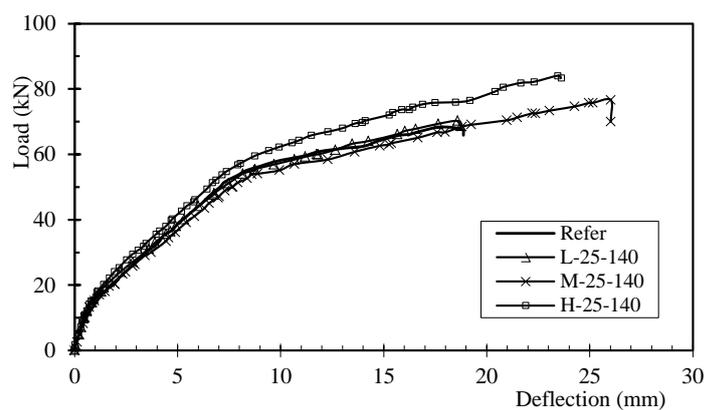
**Fig. (13).** Load *versus* mid-span deflection curves for specimens with varied interfaces.

Specimens L-25-140, M-35-140, H-25-140 and Refer form a group that allows exploration of the interfacial effects under different degrees of weakening, and their load *versus* mid-span deflection curves are shown in Fig. (13). No major difference can be identified in these curves, excluding the influence of different effective heights of the specimens, as seen in Table 2 the nondimensional results. All three specimens experienced intermediate cover delamination and failed in CFRP integral debonding after yield of tensile reinforcement. The scale of cover separation increased with the interfacial weakening, providing evidence of degradation.

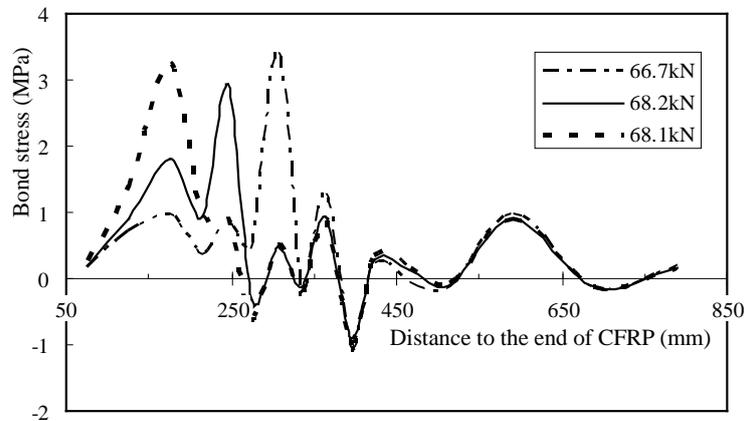
Fig. (14). Critical bond stress distribution curves of the reference specimen.

The effect of the weak interface on CFRP debonding is further revealed by the critical bond stress distribution curves of the specimens, which are shown in Figs. (14-17). Local debonding was first observed on the reference specimen at 66.7 kN, which is quite close to the ultimate load of 68.1 kN, suggesting that flexural CFRP performed fairly well in the previous stage. Local debonding tended to occur at much lower load levels for the other three specimens under the influence of weak interfaces. Actually, local debonding is more appropriately called intermediate

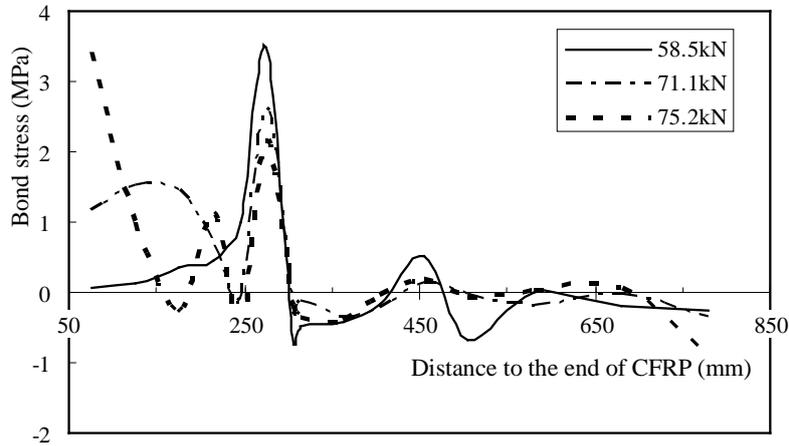
Fig. (15). Critical bond stress distribution curves of specimen L-25-140.

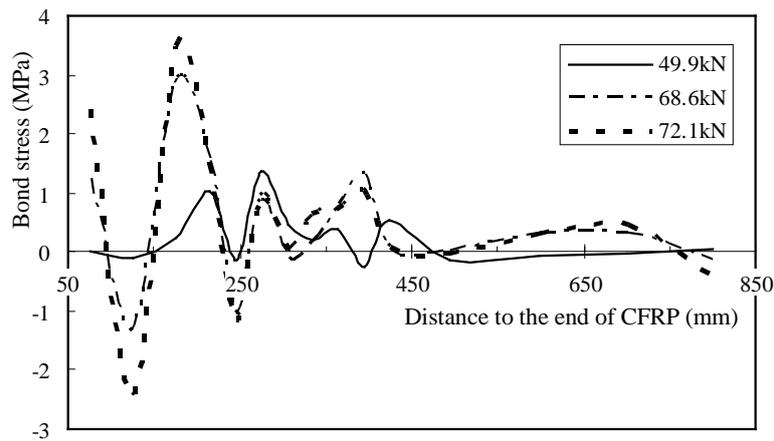
Fig. (16). Critical bond stress distribution curves of specimen M-25-140.

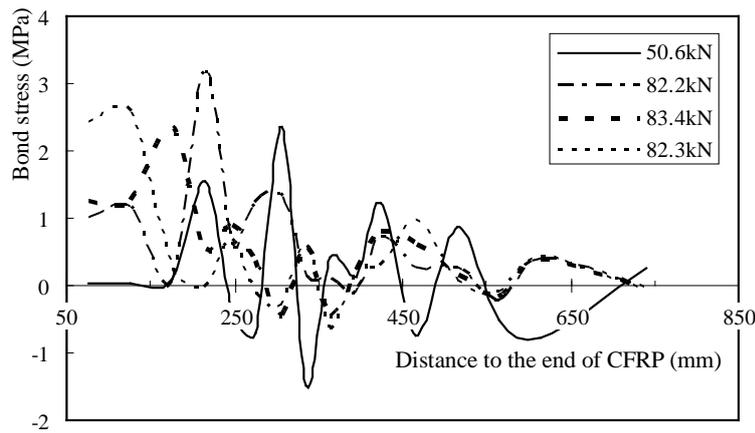
**Fig. (17).** Critical bond stress distribution curves of specimen H-25-140.

Additionally, the movement of the critical stress peak toward the support can be clearly seen by comparing the critical curves of the slightly weakened specimen H-25-140 (Fig. 17), which is similar to the reference specimen. This bond stress redistribution process, however, cannot be observed in the specimens with moderately and heavily weakened interfaces. Thus, it is reasonable to conclude that weakening of the interface will reduce the safety margin and result in more brittle debonding.

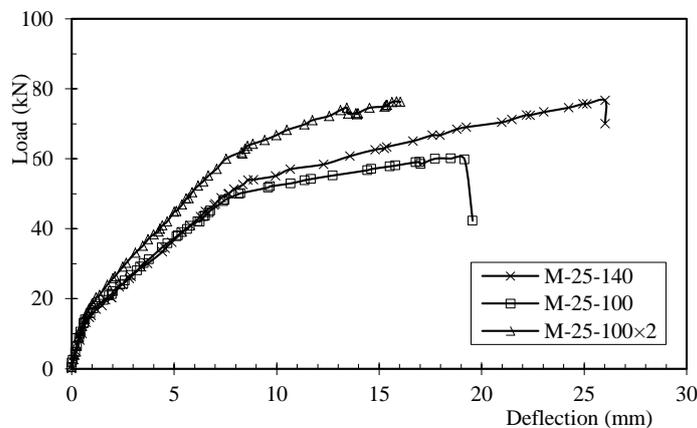
**Fig. (18).** Load versus mid-span deflection curves for specimens with varied CFRP reinforcement ratio.

The effects of the flexural CFRP reinforcement ratio were investigated comparatively using a group of specimens including M-25-100, M-25-140 and M-25-100×2; the load deflection curves for these three specimens are plotted in Fig. (18). The nondimensional results in Table 2 show that the yield load of the beams increased with the increasing of reinforcement ratio. However, this increase engenders much higher shear stress, under rapidly increasing deformation after the beam yields, which might explain the quick failure of specimen M-25-100×2. Under such circumstances, the ultimate CFRP strain was as low as 0.00551 at mid-span.

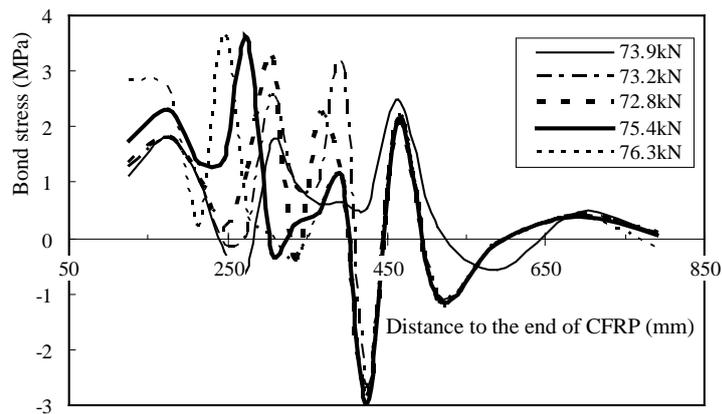
Fig. (19). Critical bond stress distribution curves of specimen M-25-100x2.

Increasing the CFRP reinforcement seems to be detrimental to the anti-debonding performance. Based on experimental observations, the intermediate delamination along the weak interface was more severe for M-25-100x2 than for M-25-100. Doubling of the flexural sheet decreased the peak enveloping area to nearly half; other key parameters were markedly reduced as well as listed in Table 3. In addition, the “critical peak movement” among the critical curves for M-25-100x2 in Fig. (19) and the relatively lower bond strength implies full development of local delamination, which cannot be observed for M-25-100 in Fig. (20).

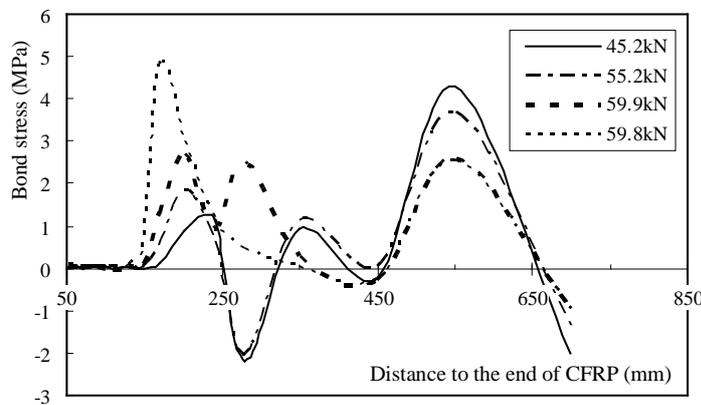
Fig. (20). Critical bond stress distribution curves of specimen M-25-100.

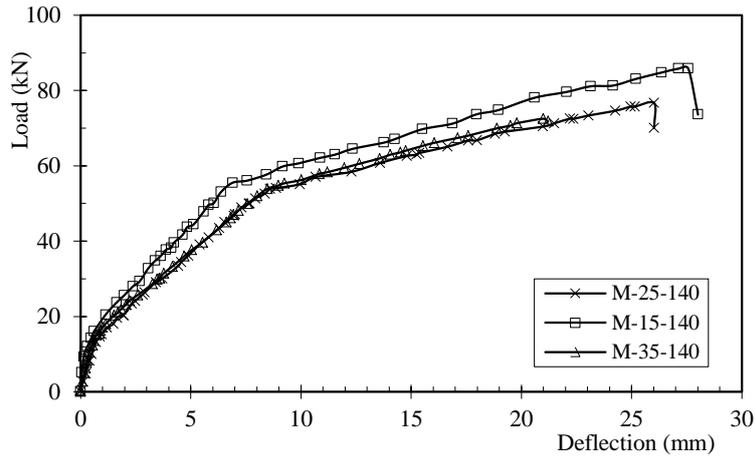
**Fig. (21).** Load *versus* mid-span deflection curves for specimens with different cover thickness.

The distance between the weak interface and the flexural CFRP depends on the thickness of the replaced concrete cover, which is likely to be an important factor affecting CFRP debonding behavior. The influence of cover thickness was inspected comparatively using a group of specimens including M-15-140, M-25-140 and M-35-140. Load deflection curves for this group are plotted in Fig. (21), and no significant difference between the curves can be seen, taking into consideration of the influence of effective height, as shown by the nondimensional results listed in Table 2.

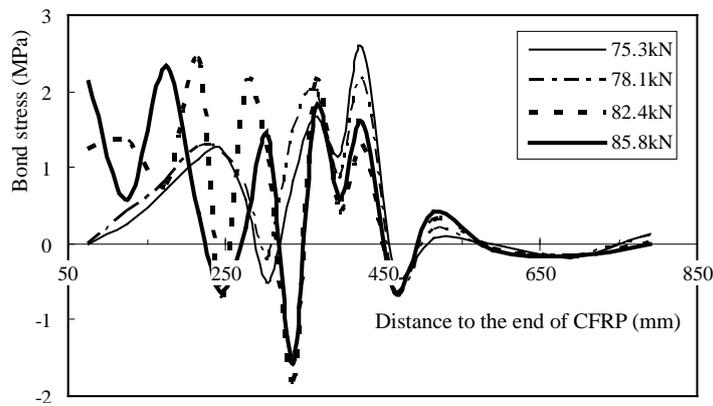
**Fig. (22).** Critical bond stress distribution curves of specimen M-15-140.

Based on the results from specimen M-15-140, a small cover thickness seems unfavorable to the shear transfer and anti-debonding performance. As listed in Table 3, the key parameters for M-15-140 are low compared to those of the other specimens. The critical bond stress curves for M-15-140 in Fig. (22) fluctuate around the X-axis in the post-delamination area, which indicates that its shear bond transfer ability has been mostly destroyed and the bond stress in this case is mainly due to cracking retraction-induced mechanical friction. Compared with M-15-140, the bond stress curves of M-35-140 tend to remain basically above the X-axis in Fig. (23), which indicates that the shear bond transfer remained intact to some extent after intermediate delamination. It is clear from the results that bond transfer length, bond peak area and shear bond coefficient all increase with the increasing of cover thickness. Although cover separation can still be observed after ultimate failure, as shown in Fig. (24), it can be concluded that debonding is less likely to be affected by the weak interface as the distance between it and the bonded CFRP sheet increases.

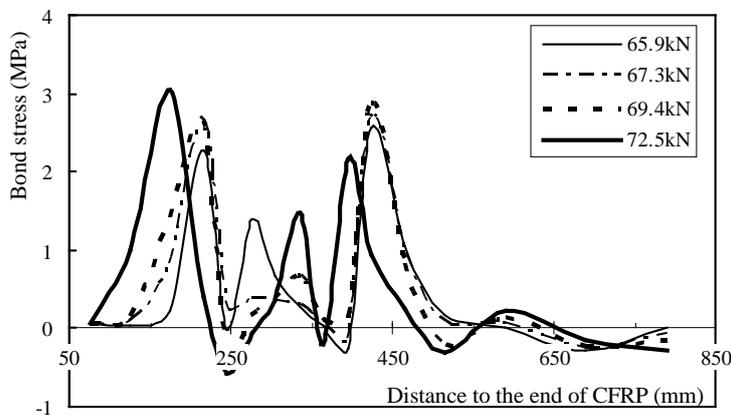
**Fig. (23).** Critical bond stress distribution curves of specimen M-35-140.

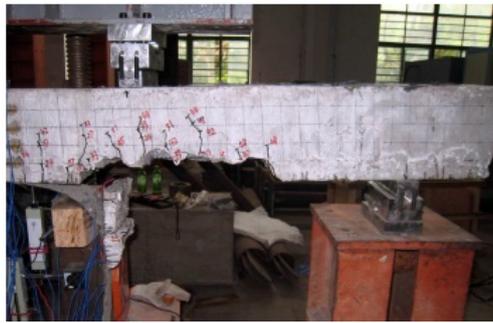
Fig. (24). Cover separation of specimen M-35-140 after ultimate failure.

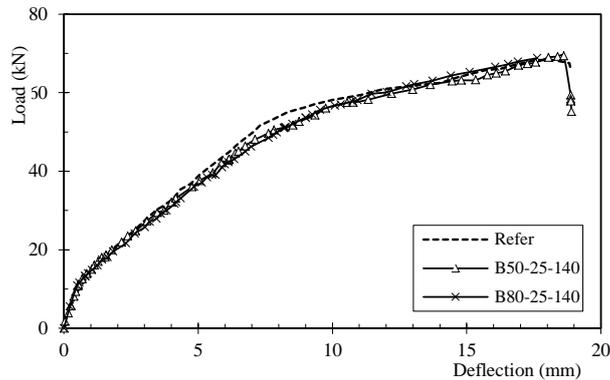
Fig. (25). Load *versus* mid-span deflection curves for specimens from Group B.

The weak interfaces of specimens in Group B were formed by preinstalled cracks. The total width of the two cracks occupied 33% and 53% of the cross-sectional width of specimen B50-25-140 and B80-25-140, respectively. The two specimens experienced a similar failure process. No distinct destruction was observed along the weak interface before ultimate failure, and the beams seemed to perform well. At the ultimate state, the concrete cover was torn up abruptly near the support and peeled off completely with the flexural CFRP sheets, as shown in Fig. (10), and the separated cover remained basically intact. Load *versus* mid-span deflection curves of B50-25-140 and B80-25-140 are plotted in Fig. (25), together with that of the reference beam. These curves are quite similar; nevertheless, the influence of the weak interface is apparent. Compared with the reference beam, the flexural stiffness decreased gradually during the loading process for both of the two specimens, especially B80-25-140, suggesting that the co-working ability of the strengthening system was weakened with loading.

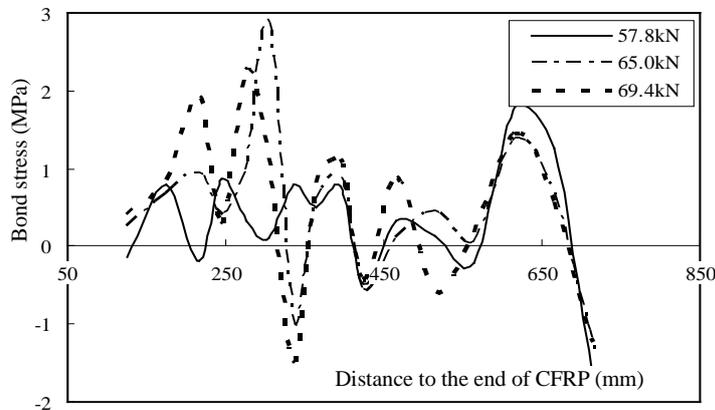
Fig. (26). Critical bond stress distribution curves of specimen B50-25-140.

Intensive transfer of shear force through the narrowed sound area is the right reason for interfacial weakening in Group B, which might explain the rather large differences observed in interfacial weakening effects between the two groups. Critical bond stress curves of specimens B50-25-140 and B80-25-140 are plotted in Figs. (26 and 27), respectively, and their debonding parameters can be found in Table 3. Compared with the reference beam, the bond strength and peak enveloping area of specimen B50-25-140 were moderately decreased, while all of the debonding parameters of B80-25-140 dropped sharply. Thus, it is reasonable to conclude that minor damage can be expected under a low level of interfacial weakening induced by cracking, and the situation worsens radically when cracks expand.

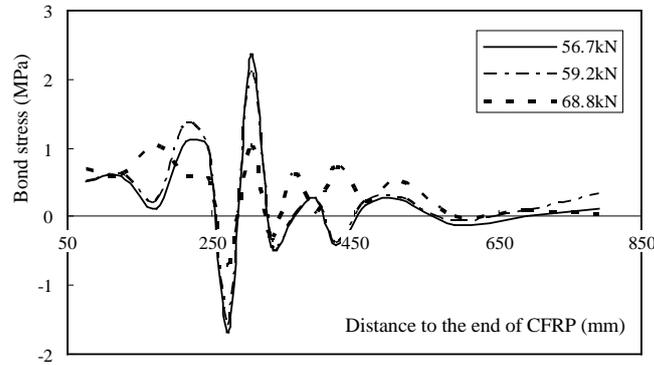
**Fig. (27).** Critical bond stress distribution curves of specimen B80-25-140.

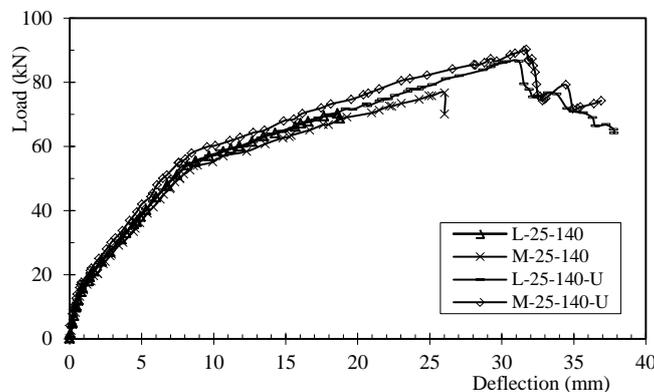
**Fig. (28).** Load versus deflection curves for U-strip confined specimens in Group A.

In contrast to the two unconfined specimens L-25-140 and M-25-140 in Group A, three U-strips were individually applied at the preset debonding ends of specimens L-25-140-U and M-25-140-U, which changed the failure modes of the two specimens from CFRP integral debonding to strip-by-strip CFRP rupture accompanied by U-strip debonding, as shown in Fig. (11). In this more ductile failure process, the loads of both L-25-140-U and M-25-140-U dropped step by step, as shown in Fig. (28). As a consequence, their load carrying capacity and deformation ability were also increased considerably. The ultimate load of L-25-140-U reached as high as 86 kN, 23% greater than the 70 kN ultimate load of specimen L-25-140. The ultimate load of M-25-140-U was approximately 90 kN, 17% greater than that of M-25-140.

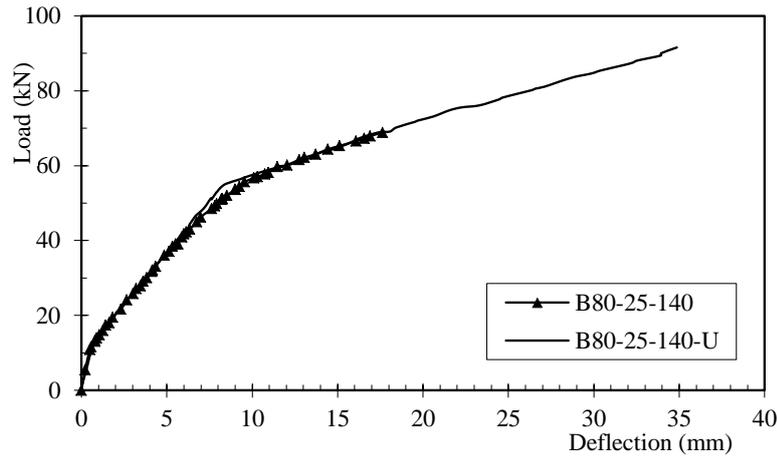
Fig. (29). Load versus mid-span deflection curves for U-strip confined specimen in Group B.

U-strip confinement seems to have been more effective for B80-25-140-U, considering that it increased its ultimate load by 33% compared with specimen B80-25-140. Nevertheless, specimen B80-25-140-U failed in a more brittle CFRP rupture, as shown in Fig. (29), with no stepwise drop of load during the failure process as observed for L-25-140-U and M-25-140-U in Group A.

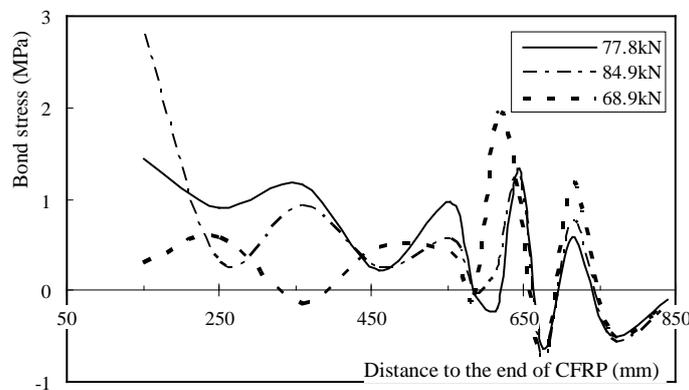
Fig. (30). Typical critical curves for specimens with U-strip confinement at the debonding end (L-25-140-U).

The effectiveness of U-strip confinement is further demonstrated by the bond stress distribution results. As mentioned previously, the debonding parameters concerning local stress peaks are less meaningful for specimens L-25-140-U, M-25-140-U and B80-25-140-U due to the large intervals between the strain gauges. This effect causes comparatively milder fluctuations in the distribution curves for these specimens, as shown in Fig. (30). In spite of this, the effectiveness of U-strip confinement can be seen by comparing the average shear bond stress of the three pairs of specimens. The average shear bond stress is increased by nearly 100% for specimen L-25-140-U and by 68% for M-25-140-U compared with their contrast specimens, as shown in Table 3. This increase was over five times for B80-25-140-U compared with B80-25-140, which shows that U-strip confinement was remarkably effective in the case of crack-induced interfacial weakening. Under U-strip confinement, the ultimate strains of the flexural CFRP sheets at mid-span all exceeded  $11000\mu\epsilon$  for the three specimens, indicating that effective performance of the flexural CFRP can be ensured.

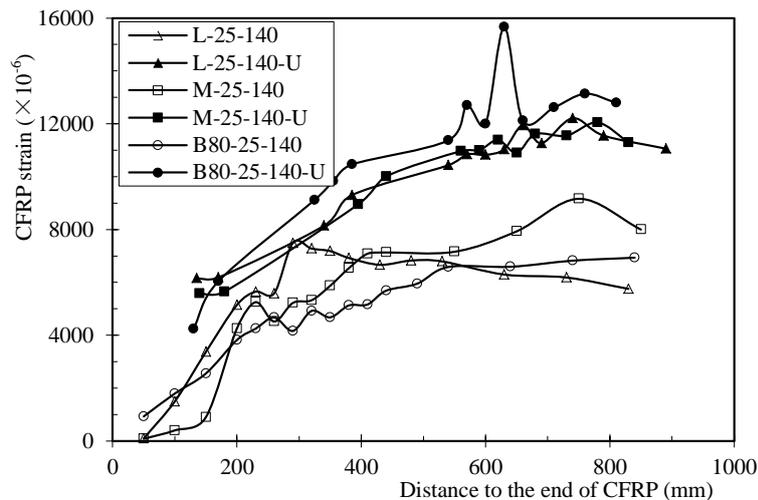
**Fig. (31).** Tensile strain of flexural CFRP sheets at ultimate states.

Despite of the effectiveness of traditional U-strip confinement, impairments due to the weak interface could not be eliminated completely. All of the failure phenomena observed occurred at the debonding end, including cover separation, U-strip debonding and CFRP rupture, while the strengthening system remained intact at the other end. Considering the symmetrical strengthening and loading, this result implies that the preinstalled weak interface at the debonding end caused the large discrepancy in performance. U-strip confinement successfully protected the strengthened beams from integral debonding of the flexural sheet; however, Fig. (31) shows that the tensile strain of the flexural CFRP reached as high as  $6000\mu\epsilon$  at the position right inside the last U-strip. Such a large value suggests an extremely high risk of anchorage failure of the flexural sheets.

Additionally, the flexural CFRP ruptured at a tensile strain lower than  $12000\mu\epsilon$ , which is far below the ultimate elongation of the material ( $17100\mu\epsilon$ ). As described above, blocks of concrete cover separated by flexural/shear cracks, and the weak interface could not deform collaboratively with the beam, which placed the flexural CFRP under a complex combination of tension, separated cover squeezing and U-strip confining and consequently resulted into the premature rupture.
