Performance Enhancement of Pre-loaded RC Short Columns Damaged by High Temperature Using CFRP Wrapping

Introduction: This study investigates the effectiveness of rehabilitating fire-damaged reinforced concrete (RC) short columns by removing the deteriorated concrete cover, replacing it with normal concrete (NC), and strengthening the columns using carbon fiber reinforced polymer (CFRP) sheets.

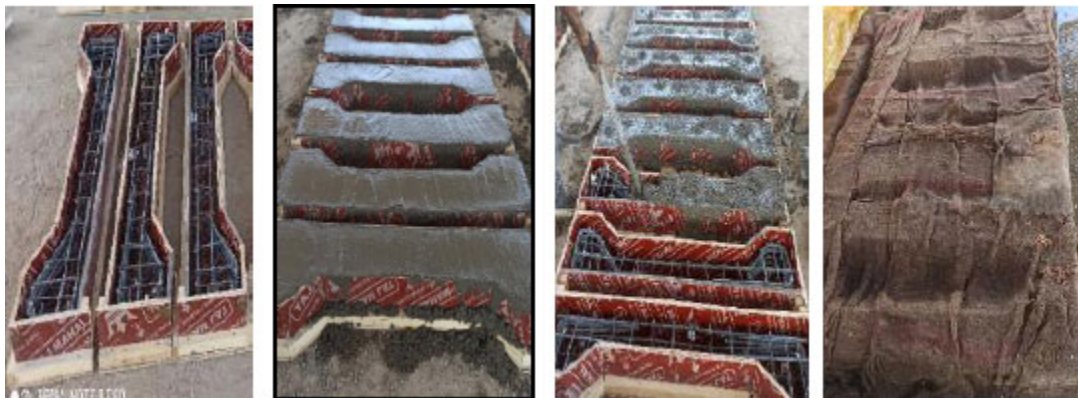
**Fig. (2).** Casting process phases.

horizontally within the wooden formwork and securely fixed in position. Concrete was poured in a single layer into each mold, followed by manual compaction and vibration for two minutes using an internal vibrator. The conventional procedures for layer placement and rodding were strictly followed to ensure adequate compaction of the concrete in the cube and cylinder molds, as illustrated in Fig. (2).

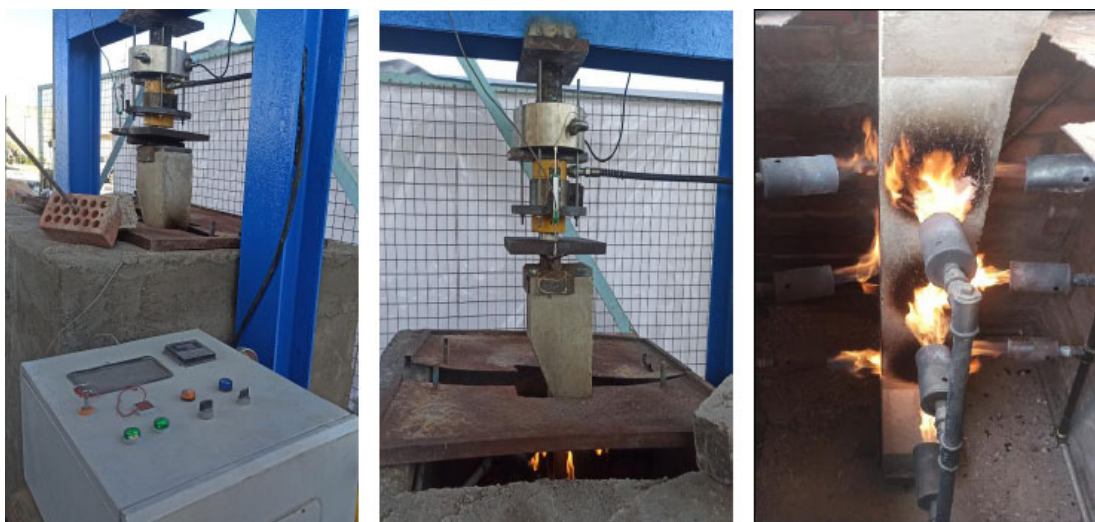
Fig. (4). Specimens subjected to fire exposure under pre-loading curve.

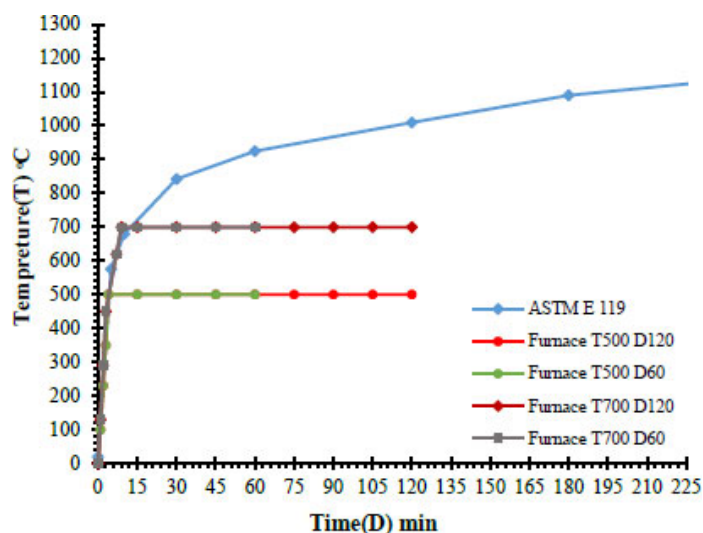
Fig. (5). Standard fire exposure according to ASTM E119-20.

to minimize their influence on heat distribution. Thermal insulation was provided near the column ends to limit heat transfer beyond the intended exposure region and to maintain a controlled heating configuration during testing. All columns were tested under eccentric axial loading. Column C1 served as the control specimen and was not exposed to fire. The ultimate axial load capacity (P_u) was experimentally determined from the control column test. Based on this measured value, columns C2 through C9 were preloaded to 178.5 kN, corresponding to approximately 50% of the ultimate axial capacity prior to fire exposure. Comprehensive details of the furnace, testing apparatus, and preloading system are presented in Fig. (4). During the fire tests, the exposure regime was carefully controlled to ensure that the average furnace temperature satisfactorily followed the standard temperature-time relationship specified in ASTM E119-20. The standard fire curve can be expressed as $T = 20 + 345 \log_{10}(8t + 1)$, where T is the furnace temperature (°C) and t is the exposure time (min). A comparison between the measured furnace temperatures and the ASTM E119-20 standard curve is presented in Fig. (5), showing good agreement throughout the fire period.

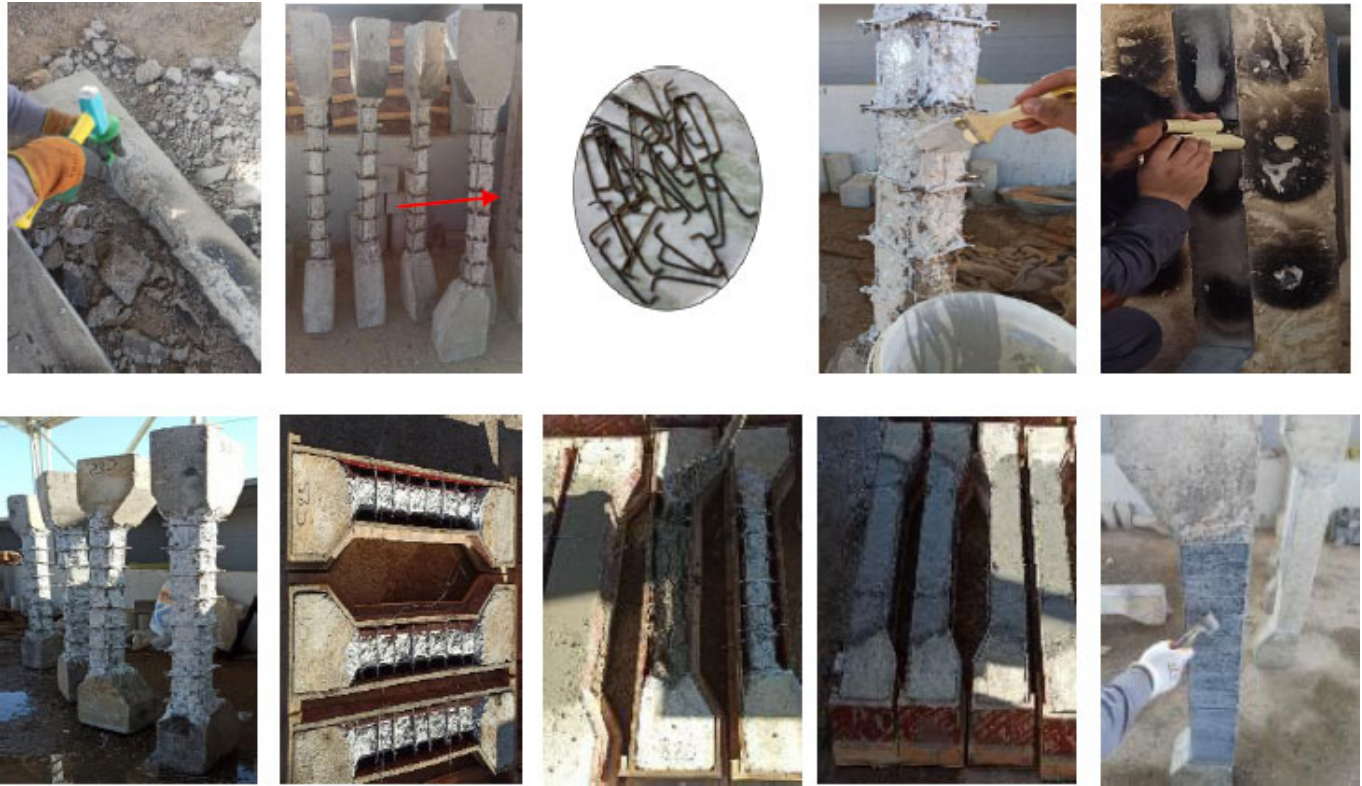
Fig. (6). Sequential steps of RC column repair.

(a) Removal of Damaged Concrete: The deteriorated outer concrete layer was carefully removed manually until the longitudinal reinforcement was fully exposed. Mechanical methods were avoided to prevent dynamic vibrations that could compromise the structural integrity of the columns.

(b) Installation of Shear Connectors: 4 mm-diameter shear connectors were installed horizontally on all sides of

the stirrups to ensure a reliable bond between the original concrete core and the newly cast normal concrete (NC).

(c) Epoxy Preparation and Application: The epoxy resin (Sikadur®-32 LP) was prepared by stirring the base and hardener separately, then thoroughly mixing them with a slow-speed drill for 2 minutes until a uniform color was obtained. Approximately 90 minutes prior to casting the NC layer, the cleaned surface of the existing concrete was coated with epoxy to enhance adhesion between the old and new concrete layers.

(d) Casting of New Concrete: A new layer of normal concrete (NC) with a compressive strength of 29.4 MPa was cast and subsequently cured for 28 days. All steps are illustrated in Fig. (6).

(4) **CFRP Sheet Installation:** The CFRP sheets were carefully placed on the epoxy-coated column surface. Pressure was applied with a rubber roller to ensure full contact and expel excess epoxy from both sides of the sheets. Any residual epoxy was removed from the edges of the CFRP sheets, as illustrated in Fig. (6).

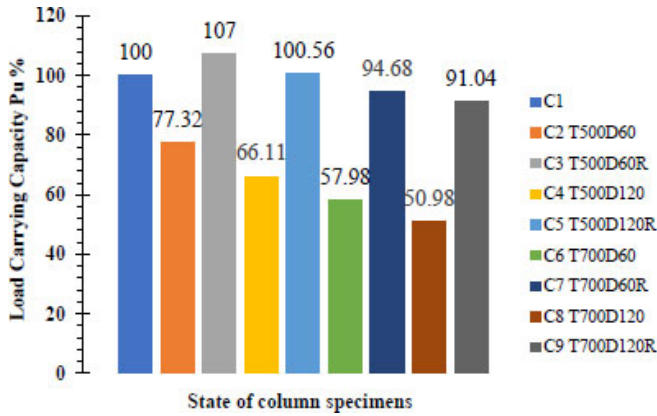
Fig. (8). Percentage of load carrying capacity for the tested column specimens.

The primary objective of this study is to evaluate the effectiveness of CFRP in enhancing the load-carrying capacity of fire-damaged reinforced concrete columns. Full CFRP confinement significantly improved the performance of specimens exposed to 500 °C, increasing their ultimate load capacity by 38.41% and 52.12% compared with the corresponding fire-damaged columns.

For the specimens exposed to 700 °C (C7T700D60R and C9T700D120R), CFRP confinement also improved the load capacity by 63.29% and 78.57% relative to their corresponding fire-damaged specimens, as shown in Fig. (8). However, despite this percentage increase, the rehabilitated columns did not recover the capacity level achieved by specimens exposed to lower temperatures due to severe thermal damage.

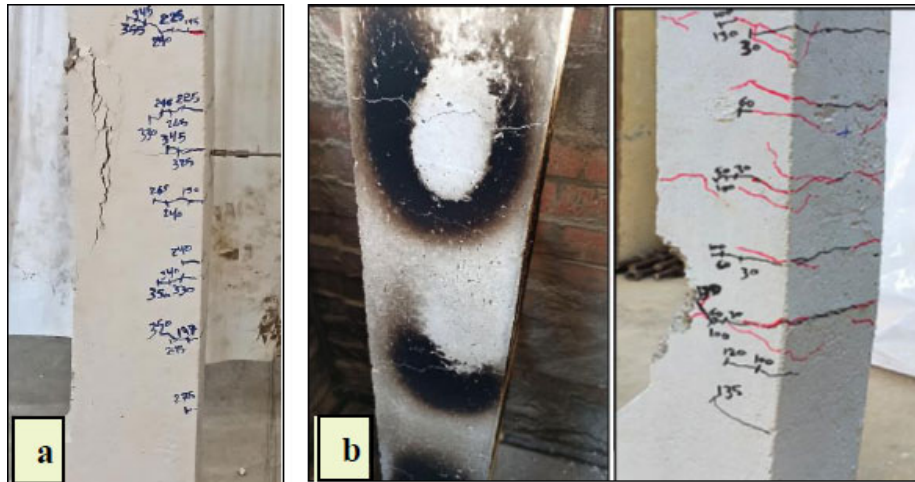
Fig. (15). Spread of crack in specimens, a. Column specimens without fire, and b. Column specimens with fire exposure.

In general, the columns were tested under an eccentric load of 45 mm. Columns subjected to this type of loading typically exhibited compression-controlled failure. The failure process initiated gradually with the appearance of cracks on the tension side, followed by their progressive propagation toward the compression zone and across the remaining faces of the column. For the unexposed control column, crack initiation and propagation were relatively slow and limited compared with the fire-exposed specimens. In contrast, the fire-exposed columns contained pre-existing cracks caused by thermal degradation, which accelerated crack propagation and widening under lower load levels, as illustrated in Fig. (15). Moreover, the ease of crack initiation increased with longer fire exposure durations; specimens exposed for 120 minutes exhibited wider and more numerous cracks than those exposed for 60 minutes at the same temperature. Failure generally occurred through spalling of the concrete cover in the compression zone within the middle third of the column. The cover then began to crush at the mid-height and subsequently developed into longitudinal and transverse cracking until the entire concrete cover was detached, as shown in Figs. (15 and 16).
