Main Reasons of Structural Wall Collapse in Chile 2010 and New Zealand 2011 - Implications For Ecuador

Maria Cristina Avalos Aguilar*, Ana Gabriela Haro and Pablo Caiza Sánchez

Abstract: Previous works on the earthquakes of Chile 2010 and New Zealand 2011 indicate regular behavior of reinforced concrete buildings with structural walls. However, some buildings suffered significant damage associated with global or local collapse due to diagonal cracking and flexural-compression failure. Structural walls located at the ground floor presented tension-compression failure was probably provoked by high axial forces at the walls extreme ends which could cause this failure in places where there is a lack of bracing and confinement.

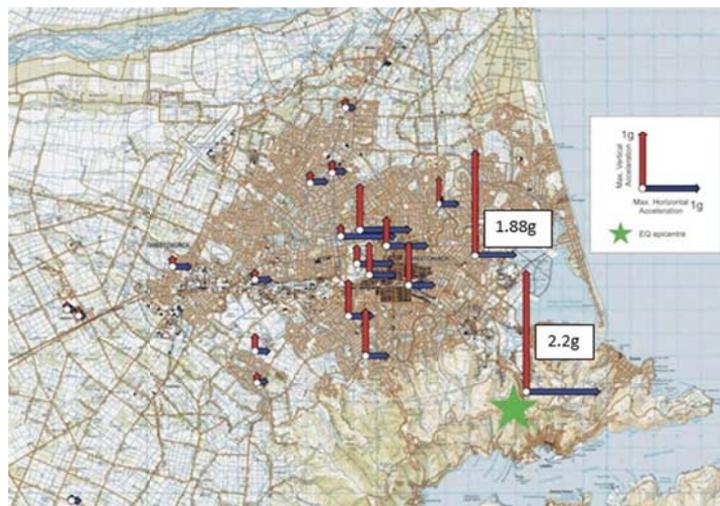
One of the factors that caused these structures to fail was the high ground accelerations. Vertical accelerations reported in New Zealand were four times higher than the Japan Earthquake on March, 11, 2011 Tohoku, 9 Mw [6]. Fig. (5) shows the reached accelerations of 2.2g sited at 6 Km from the epicenter and 1.8g in Christchurch.

For example, in the Hotel Grand Chancellor the ground shaking in the vertical direction generated amplified dynamic response from either the upper floor cantilever or the cantilever transfer beams. The current construction code did not consider vertical accelerations at cantilevers, then those elements were prone to fail [10].

Fig. (5). Accelerations at the Center of the City [9].

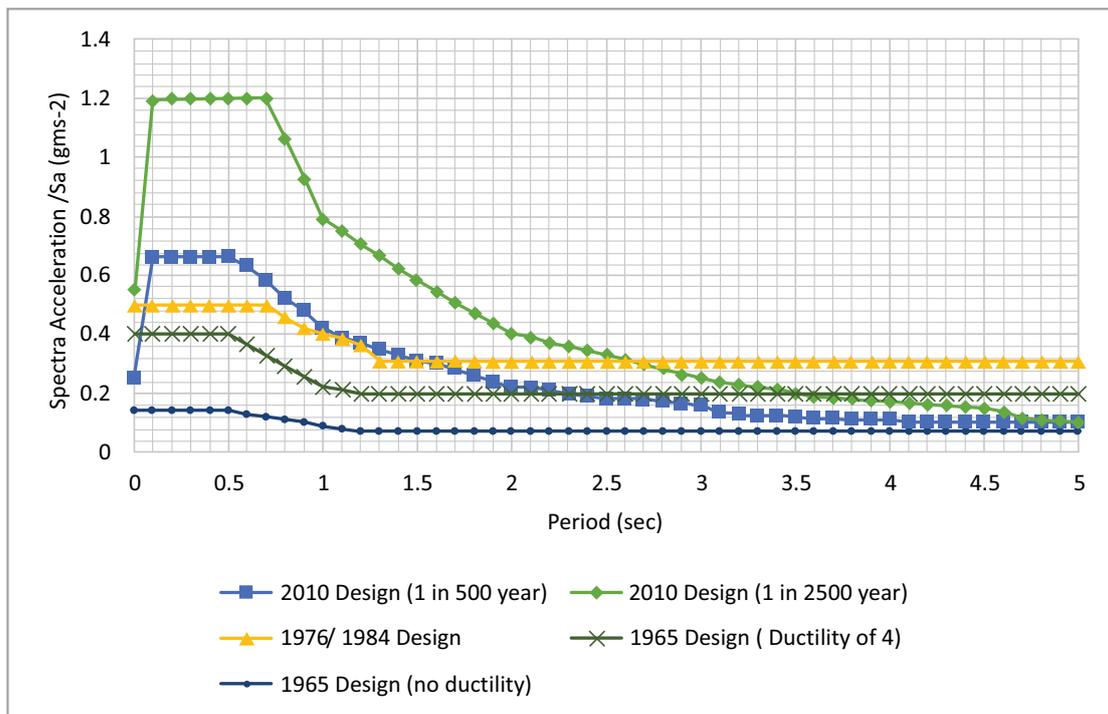
Fig. (6) depicts plots of spectral acceleration against the period. These accelerations versus periods are used to identify how buildings of different types and sizes responded to the earthquake. The vertical axis estimated the maximum acceleration of the building according to the specific ground motions. The horizontal axis represent the period of vibration of a building which increases depending on the height and building type. For example, the low-rise buildings have shorter periods, and high-rise buildings have longer periods. According to this, the PGC Building period was 0.7 seconds, and the Forsyth Barr Building was 2.4 seconds.

In addition, Fig. (6) provides a comparison of the Christchurch Earthquake demands; the blue line represents the design level of a 500-year event for the modern buildings, this curve assumes that the buildings respond elastically. The yellow line represents the design level standards of 1984 and 1976 according to their Codes. These correspond to the equivalent elastic response values, so that they are compatible with the accelerations for the ground motion records. According to the Standards, it was allowed to reduce the accelerations if the building had a ductile design. The green curve characterizes the design requirement for the Construction Code of 1965. The solid line represents the performance of the buildings with this Code in which the full ductility is achieved. The navy line correspond to buildings constructed with the 1965 standards, which caused changes in the levels of ductility to be achieved.

Fig. (6). Design versus Demand, Elaborated by Maria Cristina Avalos (Based on New Zealand Department of Building and Housing, 2012).
